5.0 REVIEW OF PHOTOGRAPHIC DATA

San Diego Photo Enforcement System Review

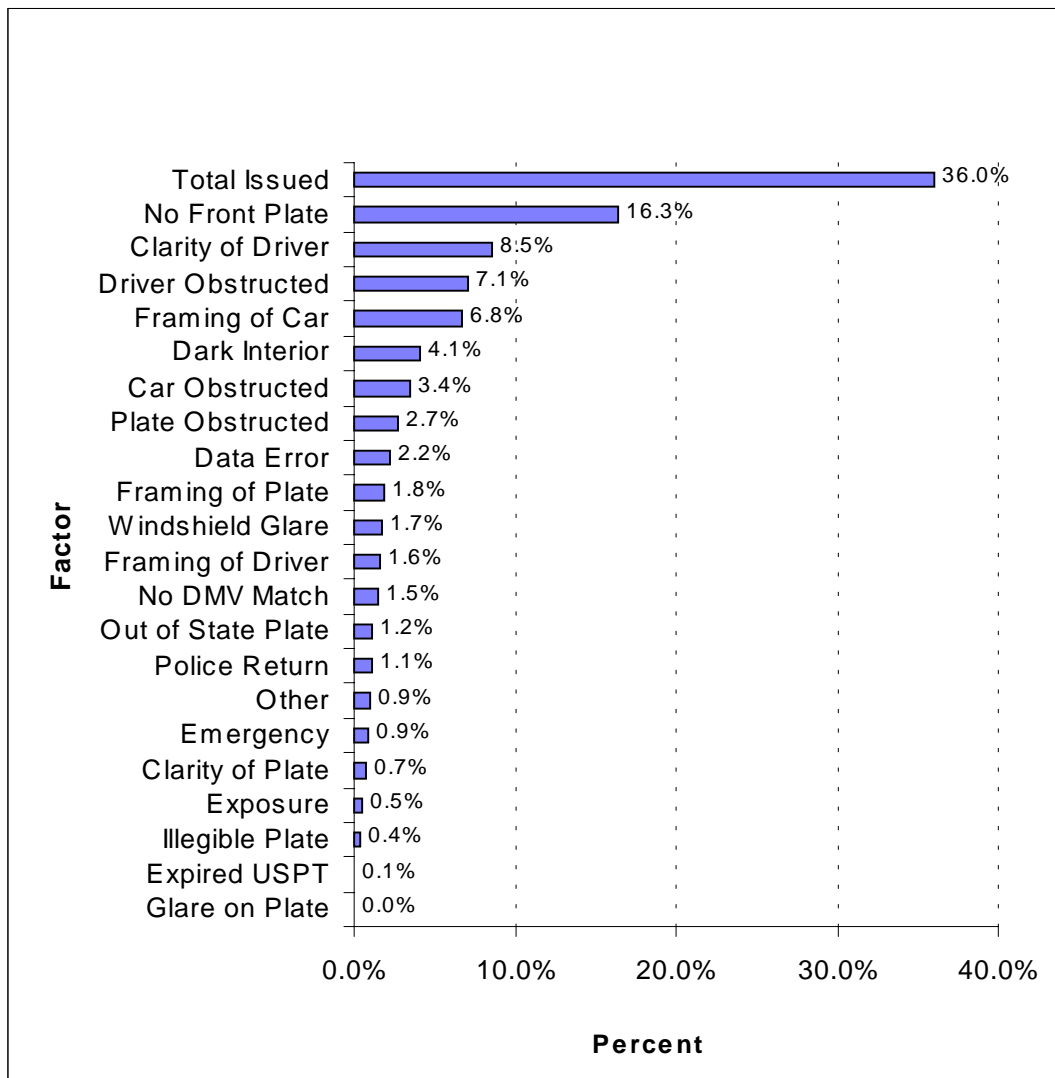
Figure 5-1
BREAKDOWN OF CITATIONS NOT ISSUED BY FACTOR

The overall contribution of each factor that prevented violations from being cited can be seen in Figure 5-1. It should be noted that, out of the 21 factors shown, some factors are clearly independent of the performance of intersection equipment. For example, “No Front Plate”, which is the largest factor for the citation failure, is not affected by the camera placement or equipment settings. On the other hand, “Clarity of Driver” may be highly correlated with the lighting conditions and the camera settings. To analyze the photographic results from each intersection, the factors shown in Figure 4-1 have been re-classified into two new groups: Intersection Related Factors and Intersection Independent Factors. Only Intersection Related Factors are used in this analysis. Intersection Related Factors are those factors that appear to be influenced by the lighting, filter, shutter speed, and other optical aspects of a camera equipment or those factors affected by the geometric relation between the picture object and camera such as camera location, height, focal length and perspective (angle and framing) of the camera.

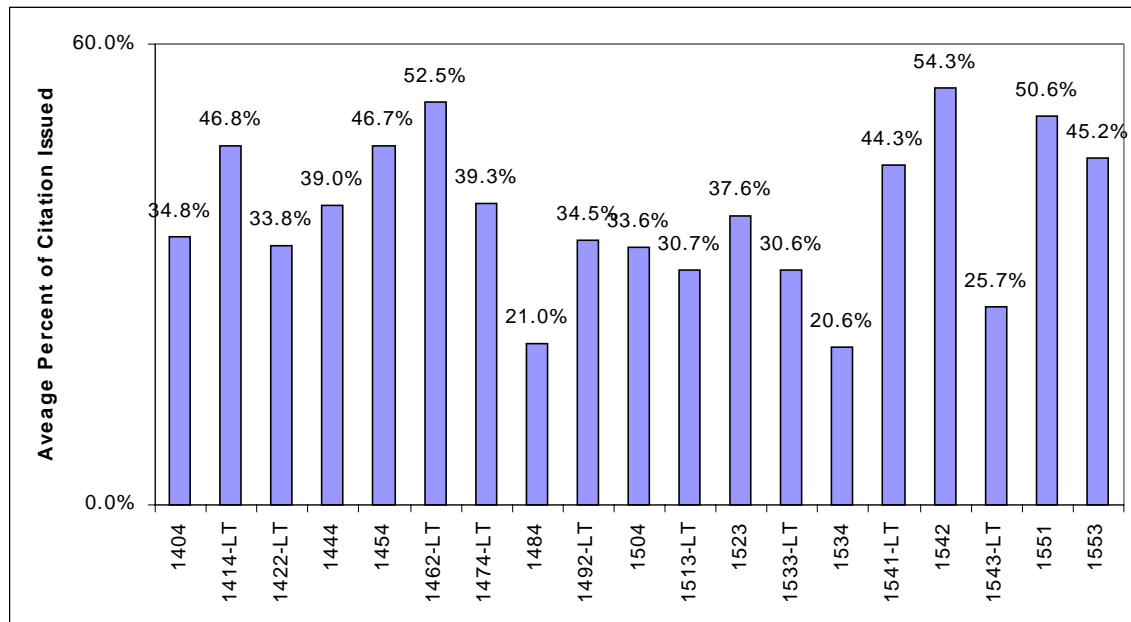
**Figure 5-2
PERCENT CITATIONS ISSUED BY INTERSECTION**

In Figure 5-2, the overall percent of recorded violations being converted to citations is presented for each of the photo-enforced locations. The percent of citations issued varies from a low level of about 21 percent for the Imperial Avenue/Euclid Street (1484) and Miramar Road/Camino Ruiz (1534) intersections to a high level of about 54 percent at the intersection of Mission Boulevard and Garnet Avenue (1542). More than 50 percent of the violations recorded at the College Avenue/Montezuma Road (1462) and Black Mountain Road/Gemini Avenue (1551) intersections are cited.

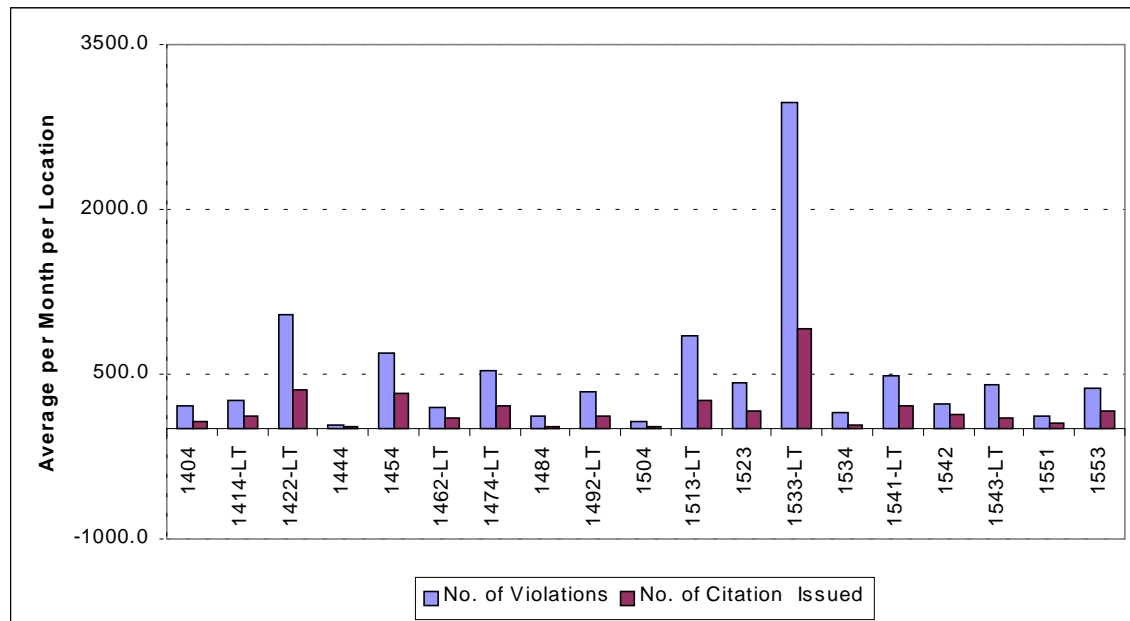
Figure 5-3
AVERAGE MONTHLY NUMBER OF VIOLATIONS AND CITATIONS ISSUED
BY PHOTO ENFORCED INTERSECTION

Figure 5-3 shows the same data for the photo-enforced intersections, but with the average monthly number of violations and citations depicted instead of the percentage of violations being cited. From this data, it is easily remarked that intersection of North Harbor Drive and Grape Street (1533) experiences a much higher incidence of red light running violations than any of the other photo enforced intersections. At this intersection, left turn violations are enforced. It may also be noted that there are very low levels of red light running at the Harbor Drive/32nd Street (1444) and F Street/Tenth Street (1504) intersections as well as moderately low levels at the Imperial Avenue/Euclid Avenue (1484), Miramar Road/Camino Ruiz (1484), and Black Mountain Road/Gemini Avenue (1551) intersections. Through red light running violations are monitored at each of these intersections where there are low levels of red light running violations.

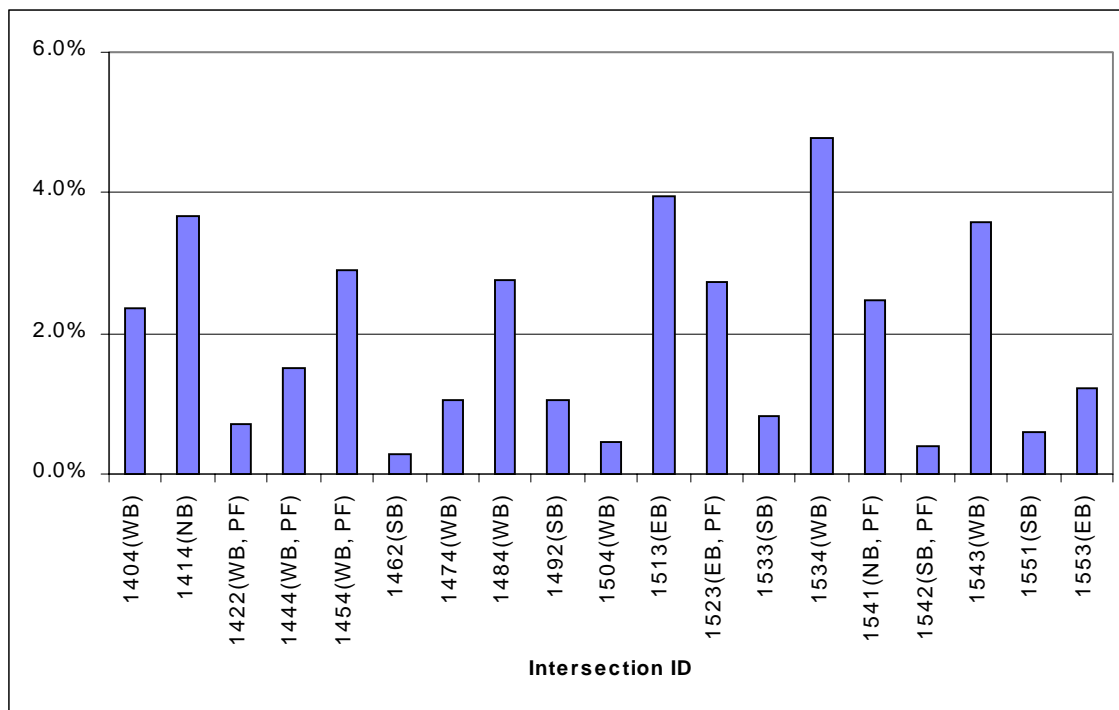
Figure 5-4
CITATIONS NOT ISSUED DUE TO WINDSHIELD GLARE

Windshield glare is caused by the sunlight reflecting off the windshield that prevents the camera view from penetrating the interior of a vehicle. Windshield glare is closely related to the time of day and the direction of vehicle movement as well as with the angle between the camera and the sun. Not surprisingly, the analysis of the windshield glare indicates that the percent of citations not used due to windshield glare is highly related to the direction of movement (see Figure 5-2). Of the nine photo-enforced intersections where the percent of citations not issued are greater than 2.0 percent, seven intersections are oriented westbound or eastbound and only two intersections are northbound. It is also noted that four of the intersections with the higher rates of citations not issued for windshield glare do not have cameras equipped with polarizing filters.

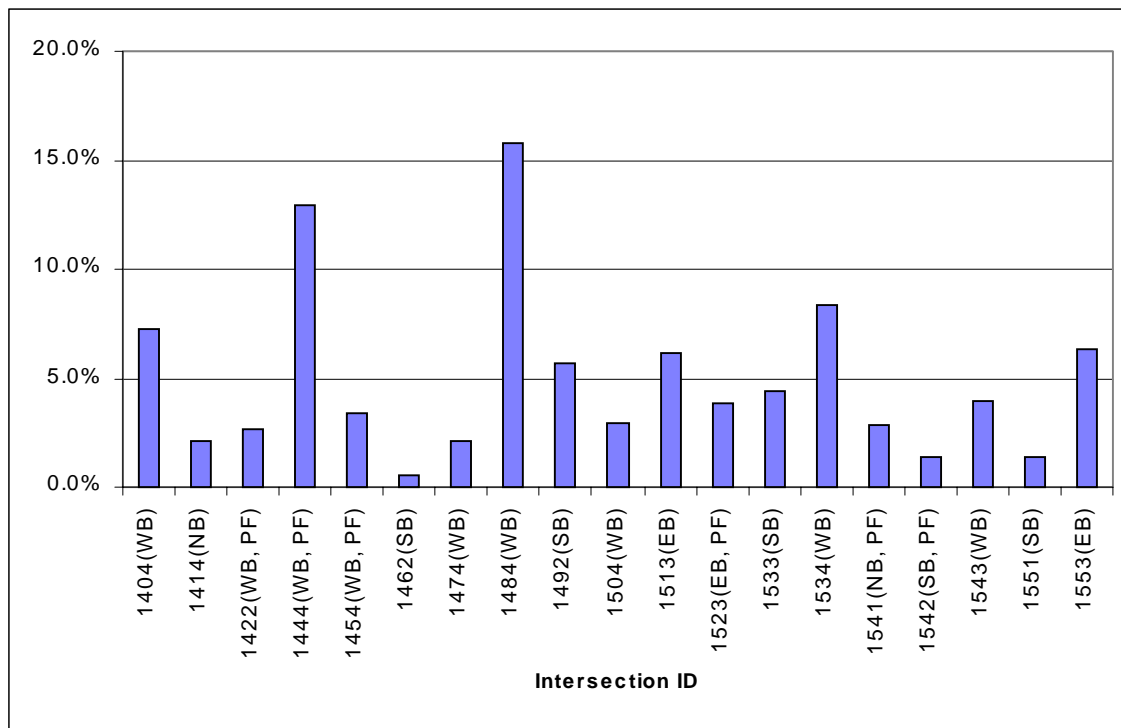
Figure 5-5
CITATIONS NOT ISSUED DUE TO DARK VEHICLE INTERIOR

The percent of citations not issued due to dark vehicle interiors and poor clarity of driver's face were analyzed. The results for these factors by intersection are highly correlated as shown in Figures 5-3 and 5-4. A total of 4.1 percent of all recorded violations could not be cited due to dark vehicle interiors. This problem results from the high degree of contrast between the vehicle interior lighting and the ambient outside lighting under strong daylight conditions. The camera exposure is adjusted automatically for the dominant ambient brightness outside the vehicle and, therefore, the interior of a vehicle tends to be under-exposed. This problem is more pronounced for vans and passenger cars with tinted windows where outside backlighting is blocked from the vehicle interior. Auxiliary flash units may be employed to mitigate the problem and reduce the number of citations not issued for this reason. The installation of auxiliary flash units at the intersections with the highest number of citations being not issued for dark vehicle interiors should be investigated.

The analysis of citations not issued for dark interiors also suggested that the problem could be related to the direction of travel being enforced. Six intersections that show higher percents of citations not issued due to dark interiors are oriented either westbound or eastbound. Cameras at four of these intersections are not equipped with polarizing filters.

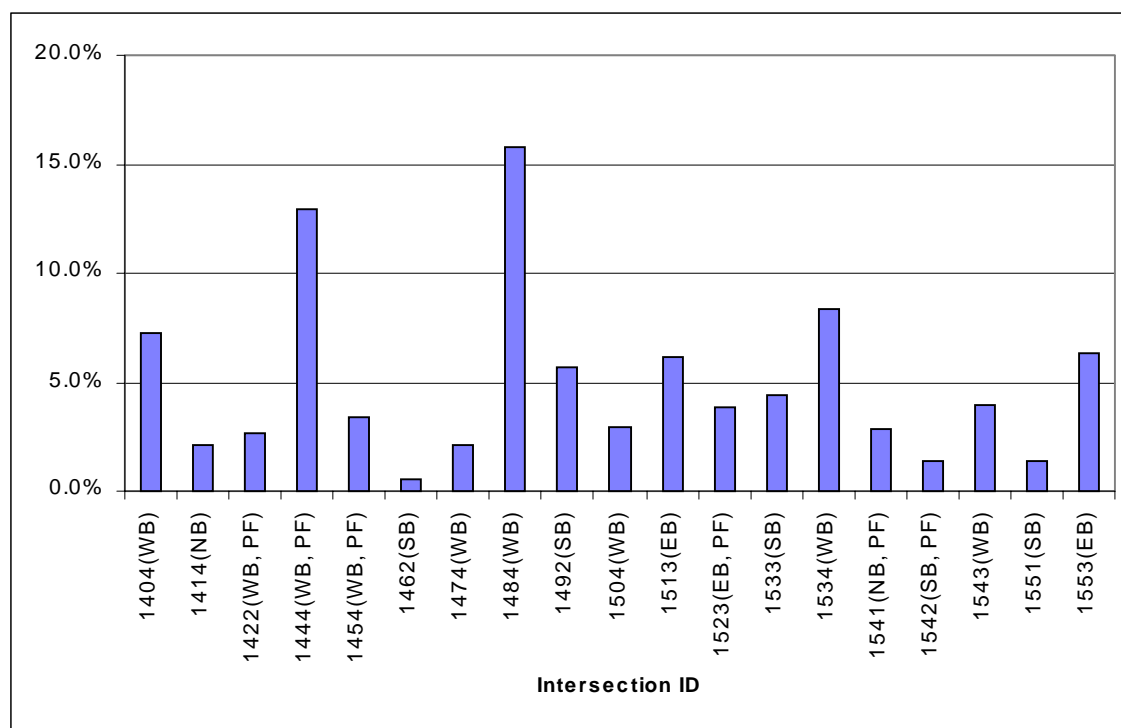
Figure 5-7
CITATIONS NOT ISSUED DUE TO POOR CLARITY OF DRIVER

The problem of poor clarity of the driver's face was the most common factor for not issuing citations, accounting for 8.5 percent of the total violations. California law requires that the driver's face be clearly visible in one of the photographs, usually the second photograph, in order for a citation to be issued. The direction of travel for the photo-enforced approaches at the intersections with the three highest citations not issued rates for poor clarity of the driver's face are either westbound or eastbound. None of the cameras at these intersections are equipped with polarizing filters.

- Approximately 14 percent of the possible violations are discarded due to lighting and optical problems where the driver's face is not clearly visible in the second photograph as required by the California Vehicle Code. Auxiliary flash units could be installed to provide additional vehicle interior lighting at photo-enforced intersections where dark vehicle interiors are a recurring problem. It is also possible that polarizing filters could be employed at additional locations, especially for intersection approaches that are oriented east and west, to increase the number of citations issued.

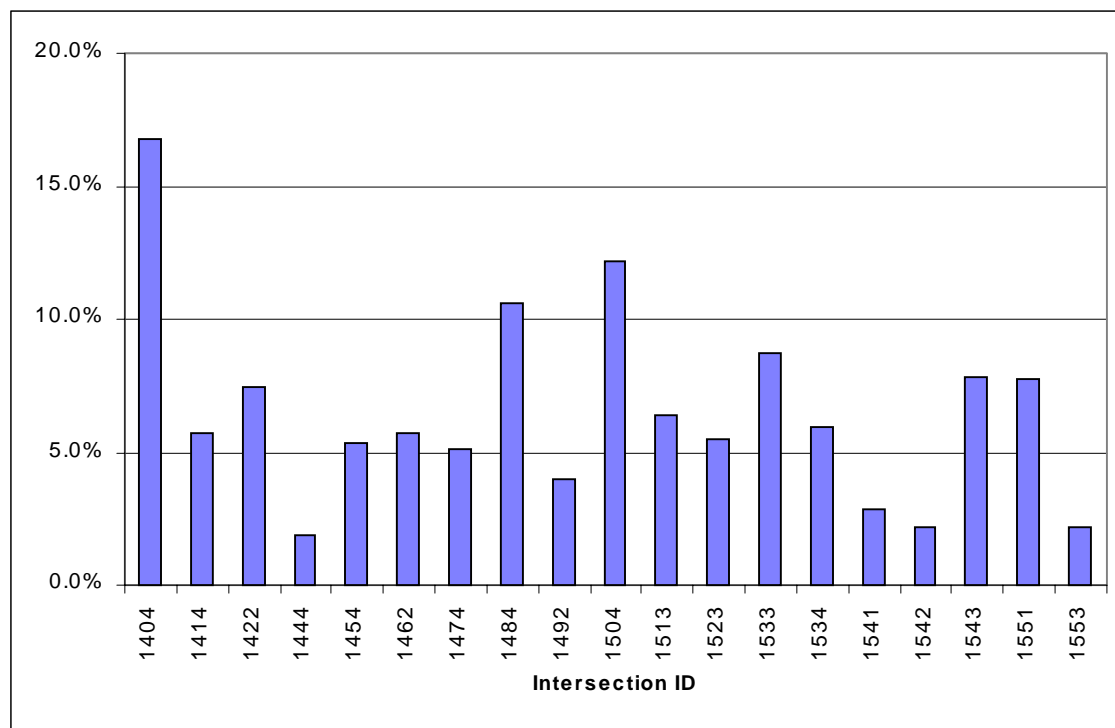
Figure 5-8
CITATIONS NOT ISSUED DUE TO DRIVER OBSTRUCTED

Driver obstruction is the second most common reason among the Intersection Dependant Factors that result in citations not being issued. Driver obstruction occurs when the driver's face is blocked by another vehicle, rear view mirror, sun visor, or vehicle roof. Figure 5-5 shows the percent of citations not issued due to obstructed views of the driver for each of the photo-enforced intersections. Intersections 1404 and 1504 show the highest percent values. The crossing streets of both of these intersections are narrow. The distances between the camera and violating vehicle at these intersections are relatively short and the vertical camera angle to the driver's face is steeper than those of other intersections with broader crossing streets.

It is possible that using a lower camera pole or relocating it further downstream from the intersection might provide an improvement for these intersections.

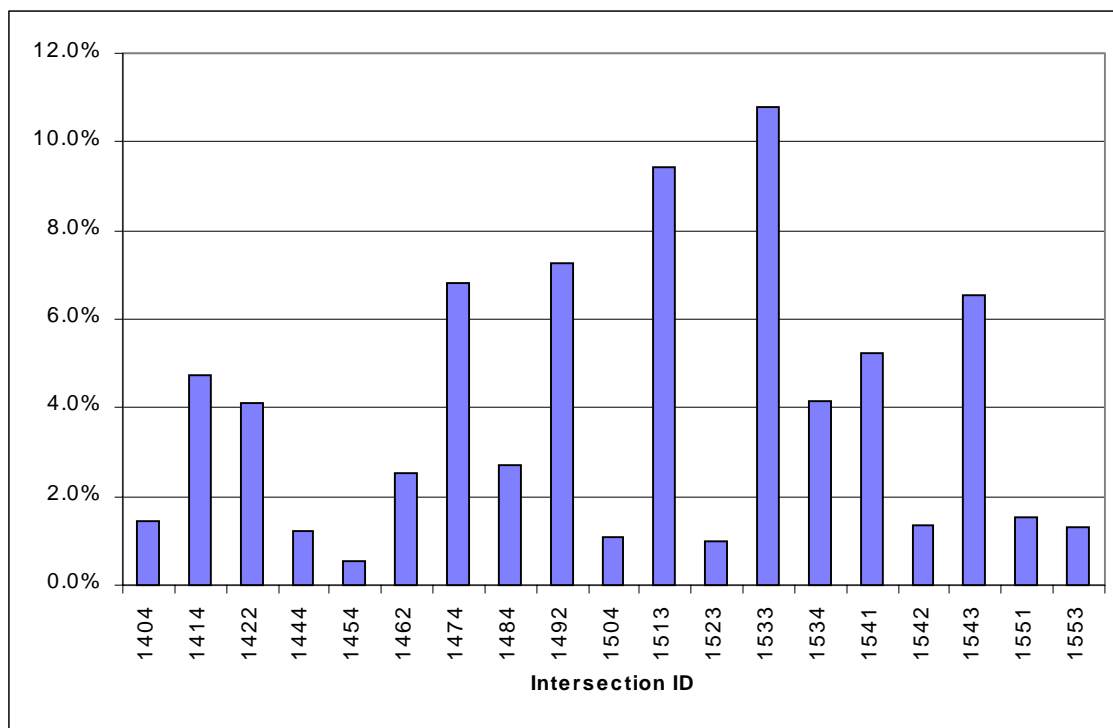
Figure 5-9
CITATIONS NOT ISSUED DUE TO LICENSE PLATE AND VEHICLE OBSTRUCTION

When the view of the license plate or vehicle is blocked by another vehicle further ahead in the intersection, it may not be possible to issue a citation. Obstructed views of the vehicle and plate occur more frequently at locations where left-turn movements are being enforced. Figure 5-7 shows that the intersections where the highest percent of citations not issued due to obstructed views of the vehicle or license plate are 1474, 1492, 1513, 1533, and 1543, all locations where left-turn enforcement is being done.

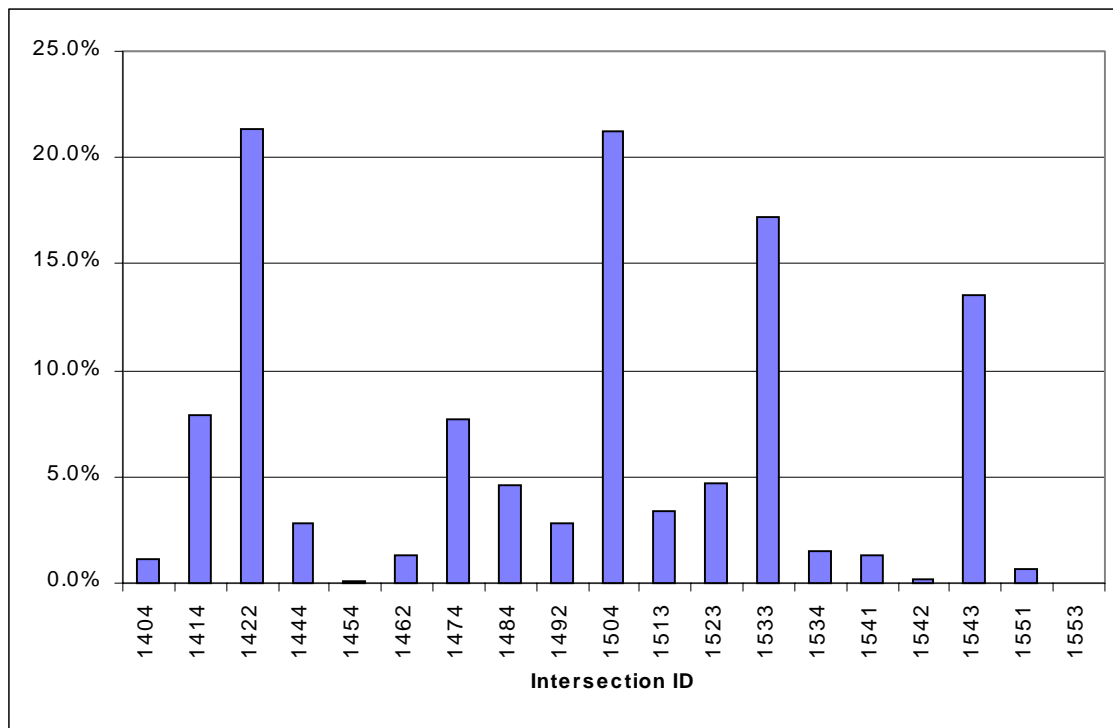
Figure 5-10
CITATIONS NOT ISSUED DUE TO FRAMING

The license plate, vehicle, or driver's face is outside of the frame of the second photograph. Poor framing may be caused by a camera lens with a focal length that is too long, poor camera angle alignment, or intersection geometric factors that result in motorists speeding up, making irregular turning movements, or being close to the camera when the second photograph is taken. Figure 5-7 shows the variations in the citations not issued for framing reasons by intersection.

Intersections 1422, 1533, and 1543 have experienced higher rates of citations not being issued due to framing problems. Enforcement at each of these intersections is for double left-turn lanes. For these locations, factors contributing to the higher rates of citations not issued are motorists speeding up as left turn movements are being completed (especially if being done against a red traffic signal), irregular turning movements, and a relatively shorter distance from the camera to the point where the second photograph is taken. Figure 5-8 summarizes the citations not issued data combined for obstruction and framing factors for this type of left turn lane enforcement, showing higher rates of citations not issued for left turns and left turns combined with through traffic enforcement.
